Dakota Access, LLC
Dakota Access Pipeline Project- Pipeline Terminals
McKenzie, Mountrail and Williams Counties, ND
ND PSC Case No. PU-14-842
Keitu Project No. 567-1099

Site/Project Location: Stanley Terminal

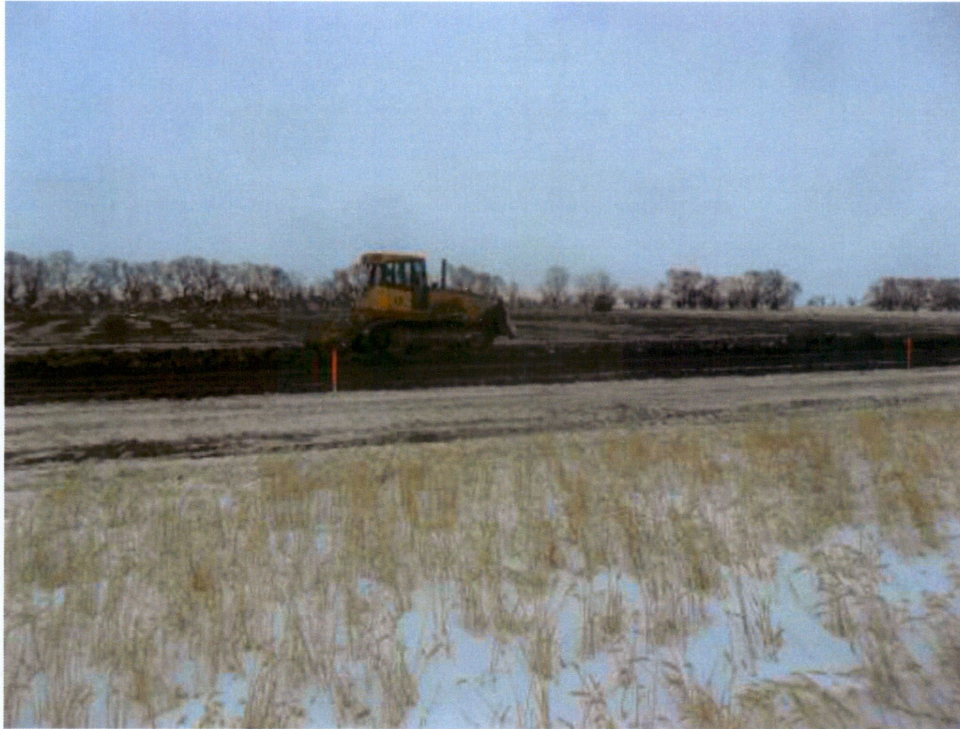
Topsoil is being moved for storage at the southeast corner of the site. Topsoil from subsoil segregation appears adequate.

Upon initial visit, Keitu inspector informed Site Chief that it appeared dozers were stripping too deep. Upon consulting with a Matrix representative and Site Chief, two small areas had some subsoil mix with the topsoil due to the frozen ground. After consultation, overall proficient segregation on site was demonstrated. Perimeter storm water sediment control measures were not in place at the time of inspection.

Report Photo #1 "Topsoil Stripping" at GPS Coordinates:

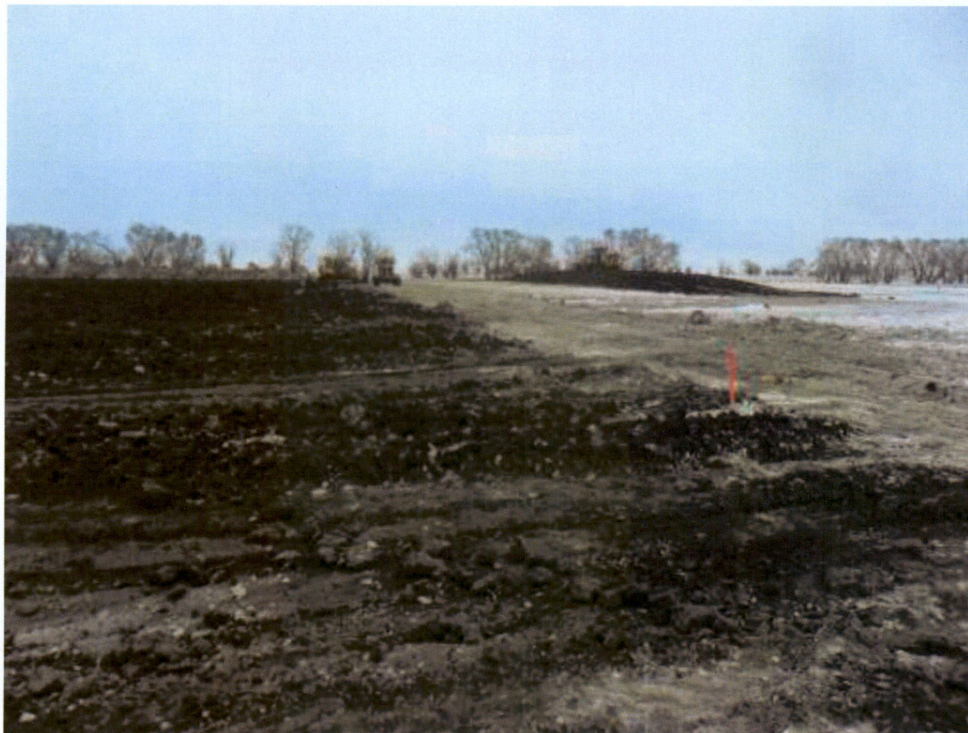
Report Photo #2 "Topsoil Piling on Southeast Side" at GPS Coordinates:

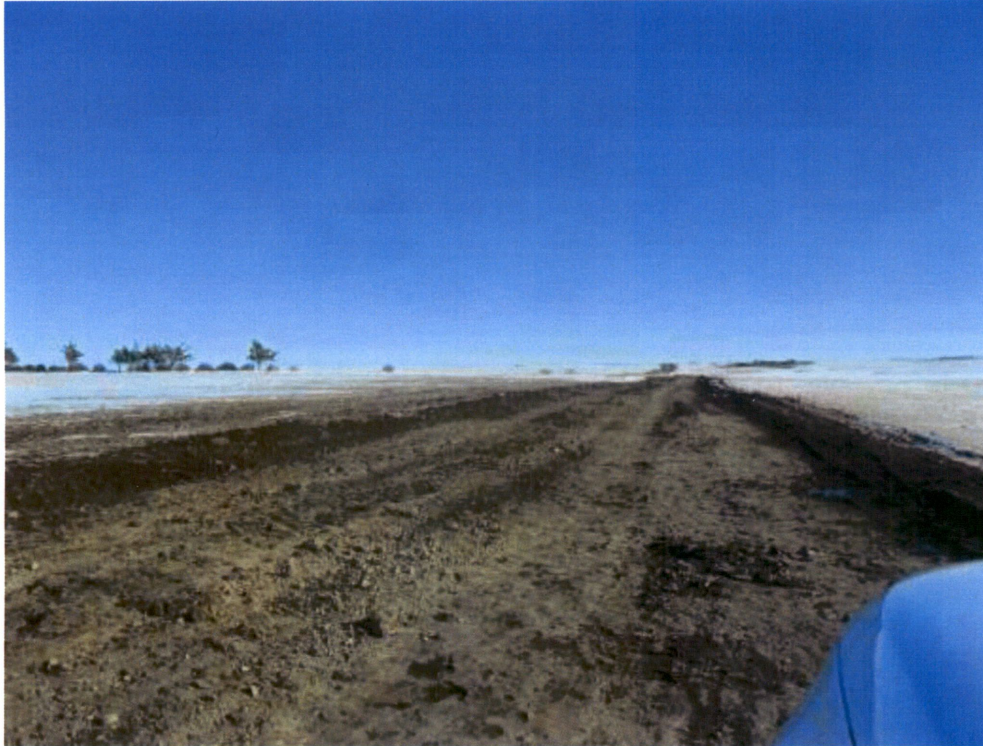
Upon visit, Keitu inspector was informed by Site Chief that subsoils were being piled on an offsite location per landowner request. Temporary road was built for access on site and adjacent landowners property to deliver soils to landowner. Unclear whether a PSC permit was granted/necessary for this work. Subsoil piling was halted in the afternoon due to sediments being tracked offsite due to thawing ground.

Report Photo #1 "Access Road to Offsite Subsoil Piling" at GPS Coordinates: 48.298194°N 102.455°W

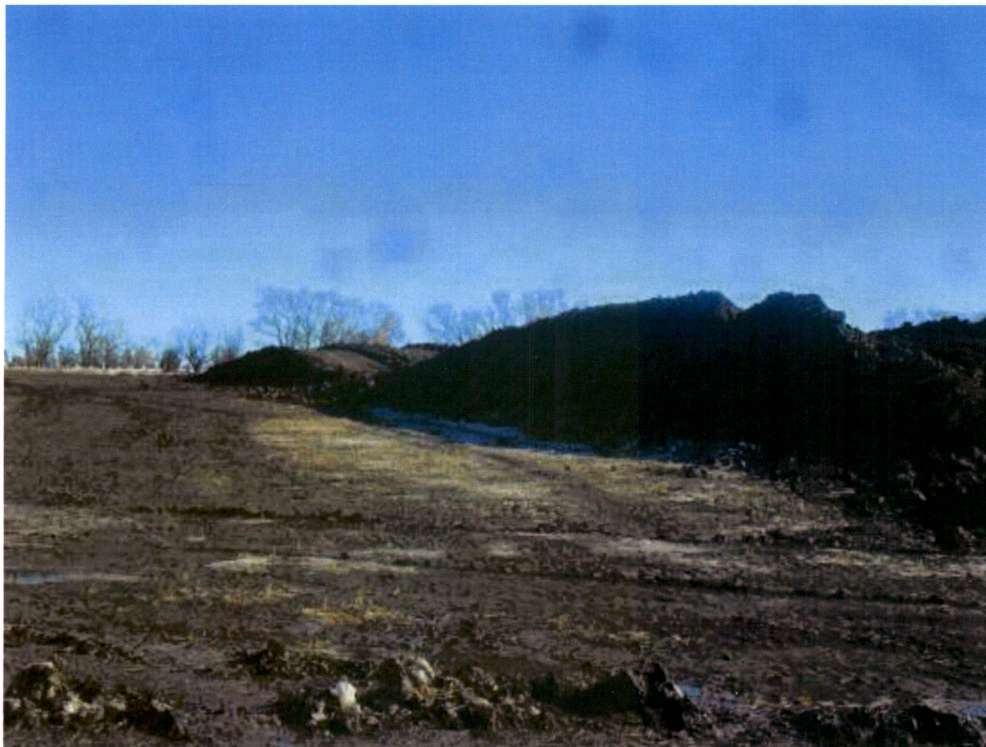
Temporary storage of subsoil had been piled on top of unstripped frozen topsoil per decision made by site construction manager.

Report Photo #2 "Subsoil Piling on South Side" at GPS Coordinates: 48.302222°N 102.460278°W

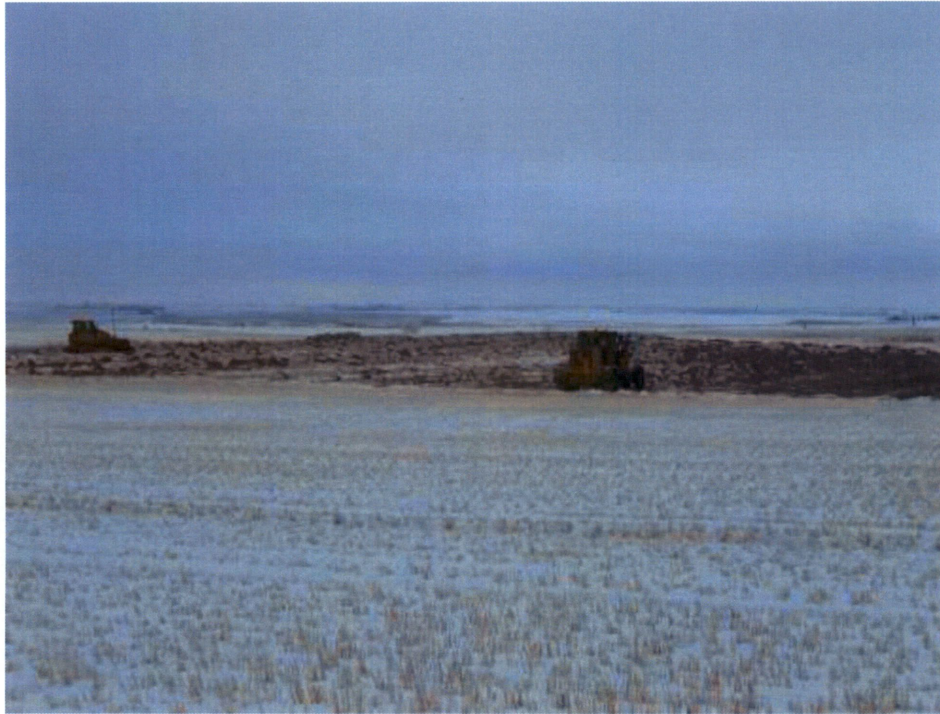
Report Photo #1 "Southern Cut" at GPS Coordinates:

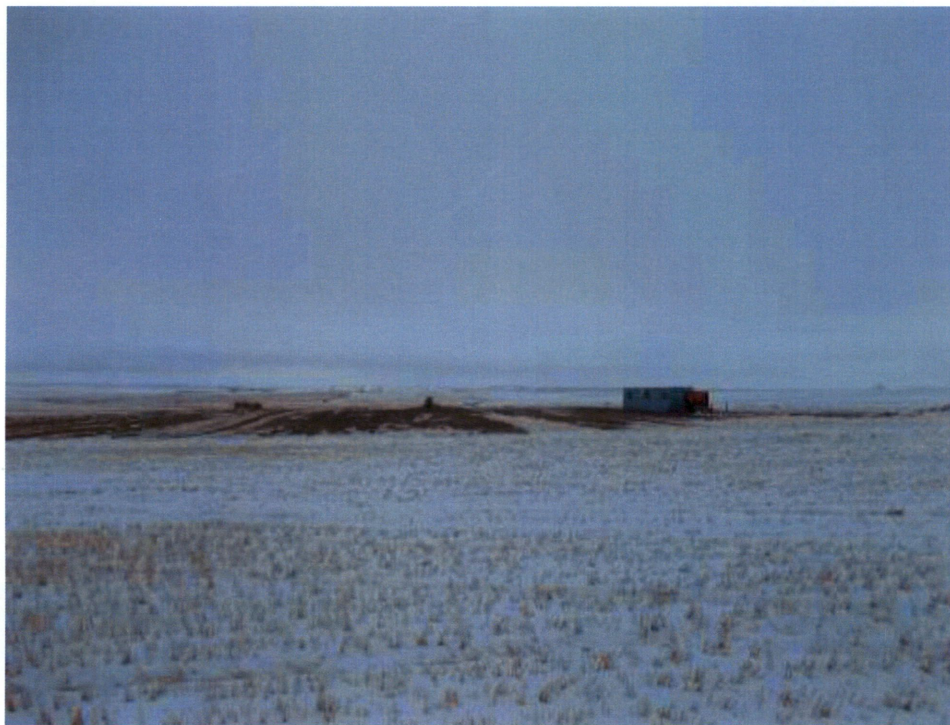
Topsoil is being moved for storage on western edge of northern cut. At the time of inspection sub soil had not been reached yet. Crews were clearing snow and loose top soil so that frost would be accessible to ripping.

Report Photo #2 "Northern Cut" at GPS Coordinates:

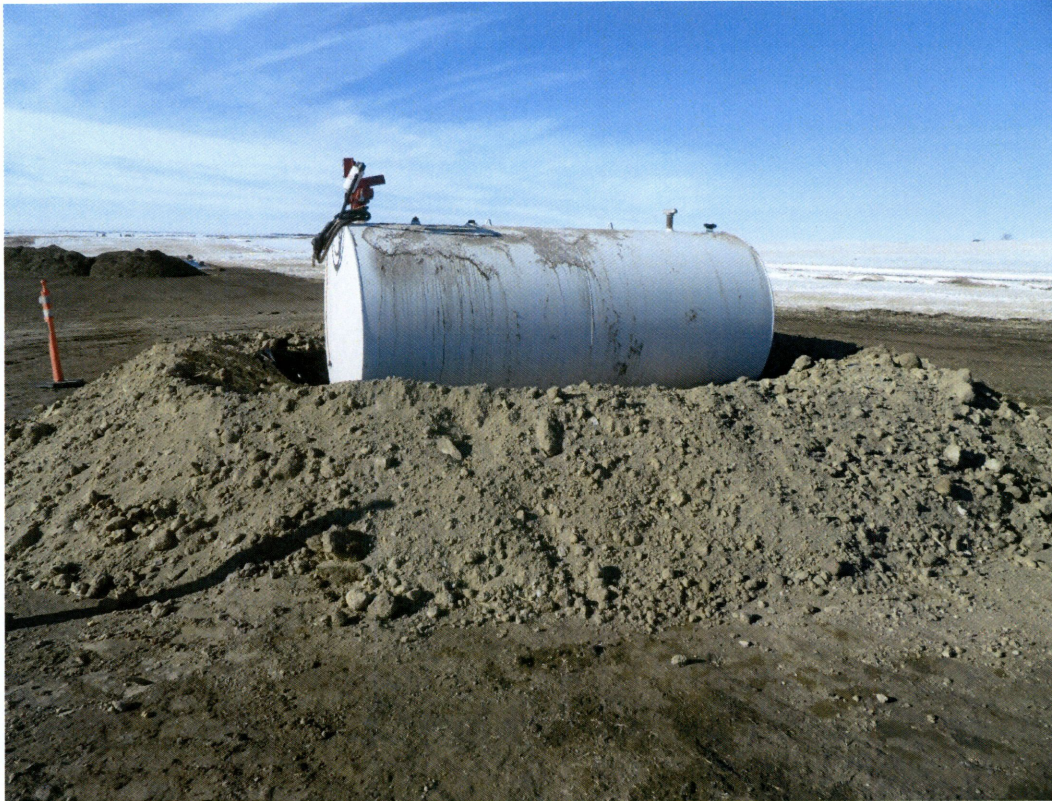
Soil berm had been installed around on-site fuel tank.

Report Photo #1 "Containment Berm" at GPS Coordinates:

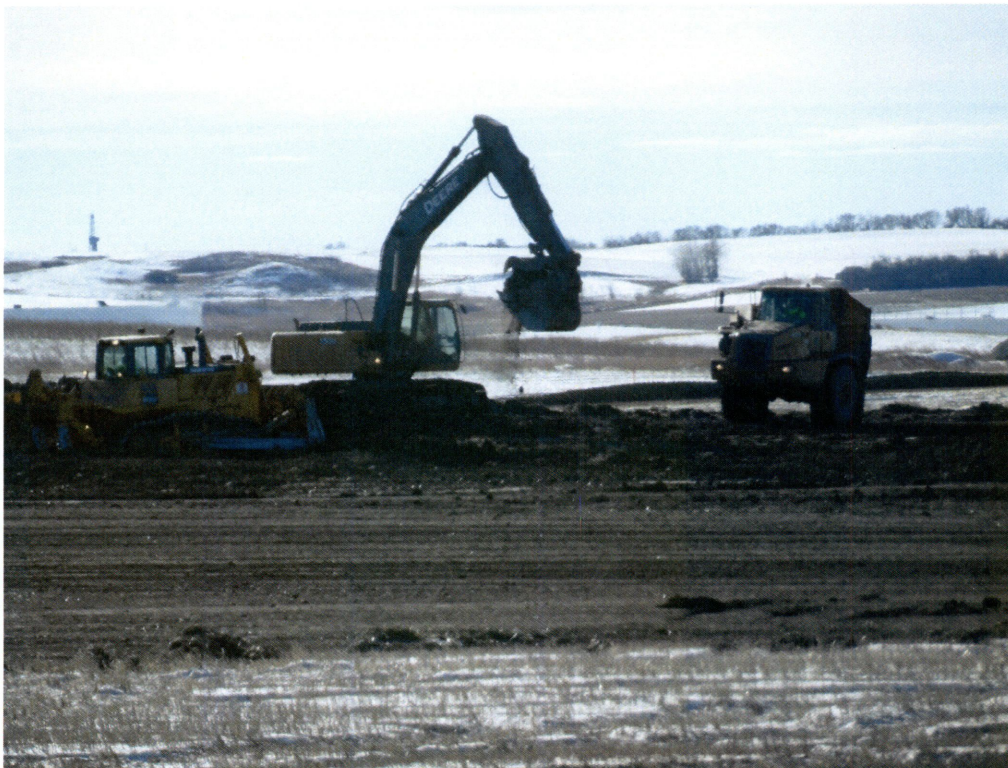
Topsoil stripped from approximately half of site. Top soil stockpile in northwestern portion of site. Subsoil pile on north central portion of site, stacked on ground stripped of topsoil. Stormwater perimeter berms installed along south and western boundaries to retain stormwater on site. Stormwater retention pond reportedly to be installed at southwestern corner of site, which is consistent with exiting natural topography. Topsoil segregation appears adequate.

Report Photo #2 "Subsoil Recovery & SW Perimeter Berm" at GPS Coordinates: 48.2939°N 102.9164°W

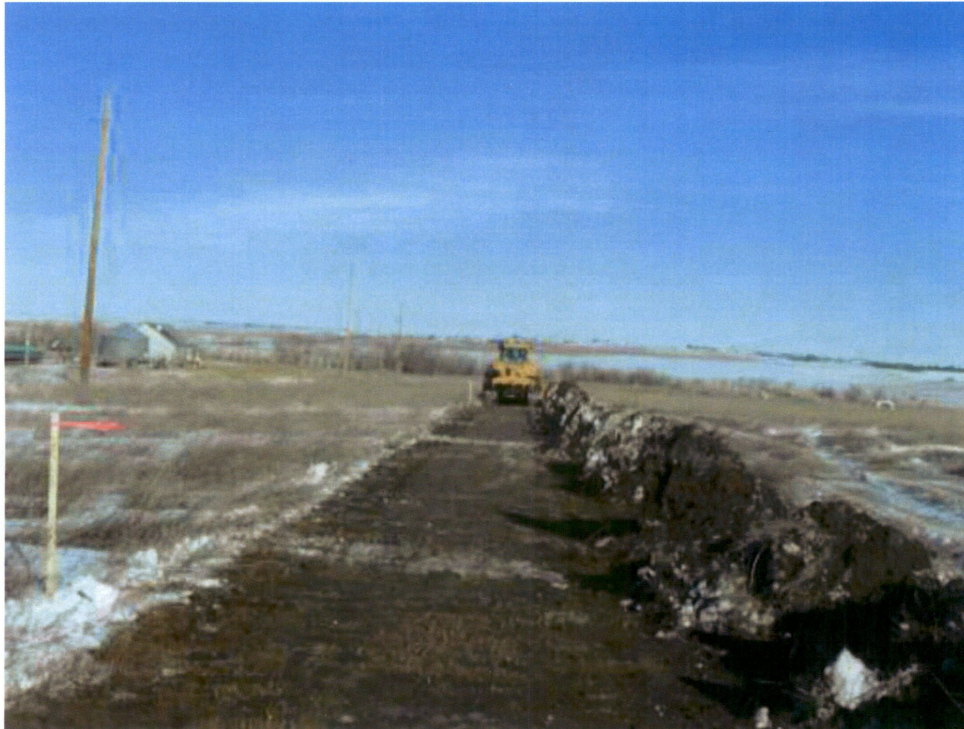
Some large deep chunks of topsoil were being lifted by the bulldozer equipment, but the warm weather was aiding in separation of topsoil from subsoil. Information provided at the pre-construction meeting indicated no tree/shrub removal was expected, and is not consistent with the information given by site personnel.

Report Photo #1 "Topsoil removal as west boundary line" at GPS Coordinates: 46.1122°N 103.7696°W

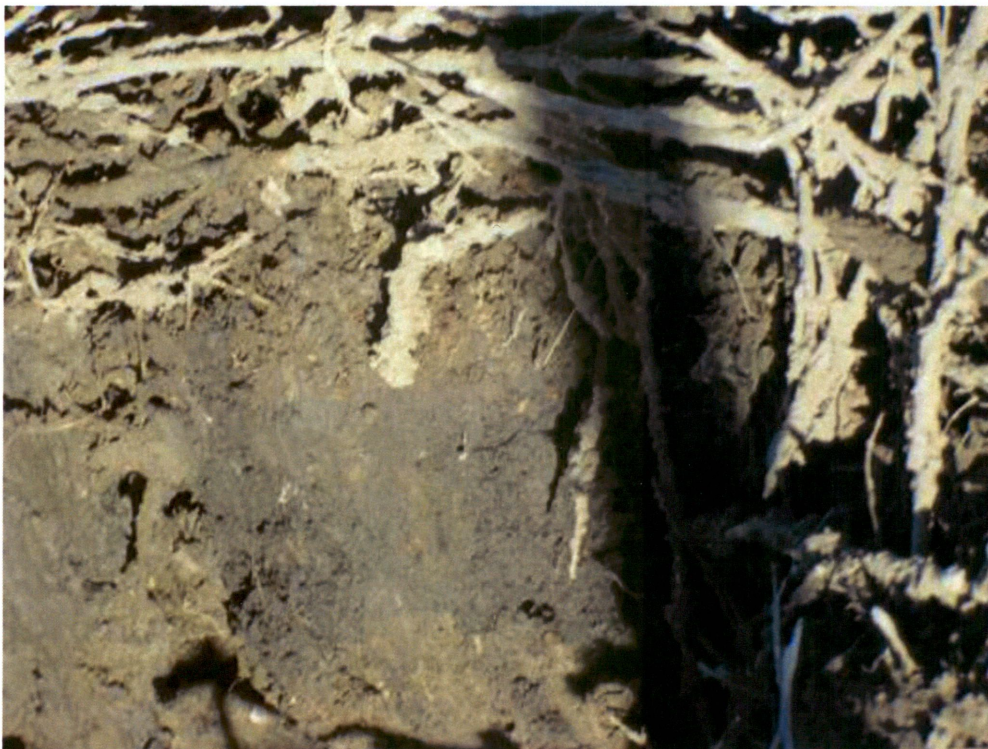
Topsoil from subsoil segregation appears adequate. Site staff expecting 9 inches of topsoil. Approximately 6 inches of topsoil evident in bell holes dug along south portion of site. Stormwater / sediment control were not yet in place although no signs of runoff / snowmelt flow were noted.

Report Photo #2 "Six (6) Inch Topsoil depth" at GPS Coordinates: 46.1114°N 103.7694°W

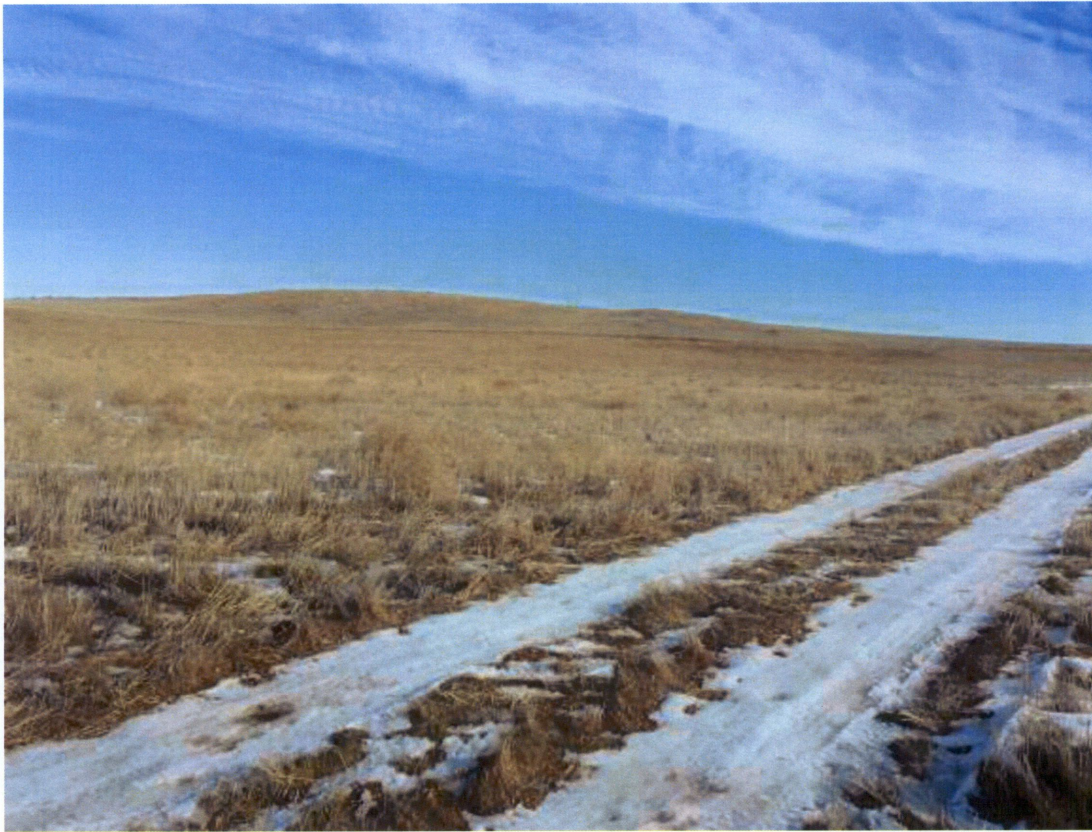
Report Photo #1 "Site Overview" at GPS Coordinates:

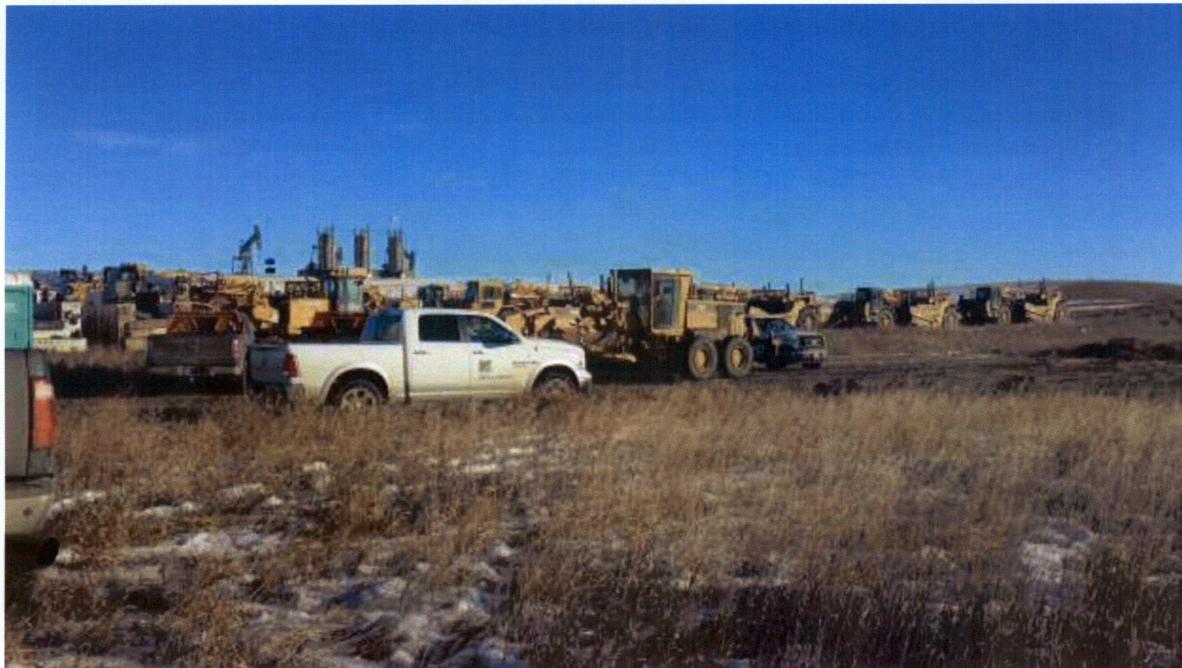
Office trailer and equipment staging occurred on the north side of Dakota Access property adjacent to 24th Street. Vegetation was trimmed in a majority of the staging area.

Report Photo #2 "Equipment Staging Area" at GPS Coordinates:

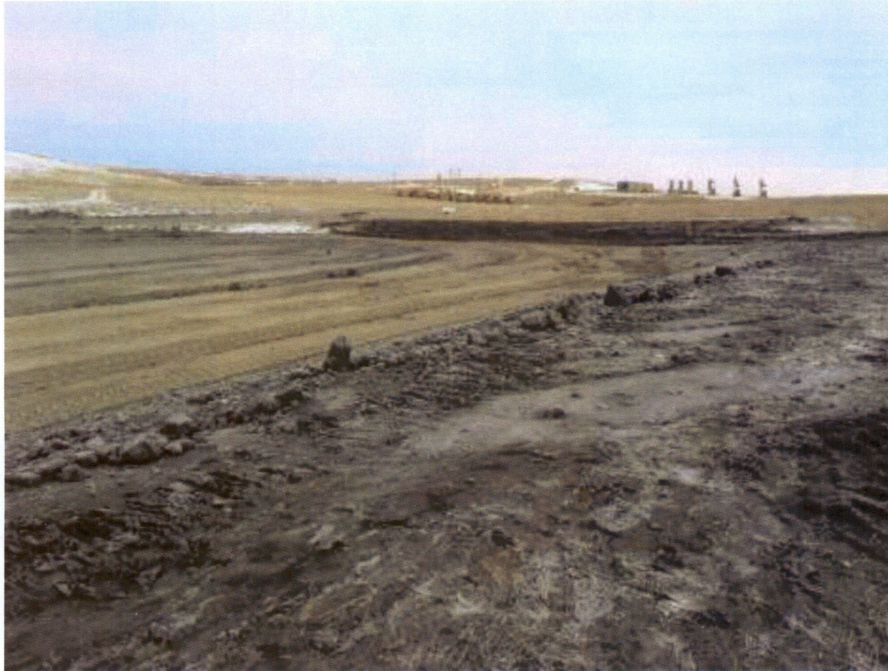
Topsoil was observed being utilized for berms on the southwest area of the site. Topsoil was used for berms on the edge of the sediment pond. Topsoil separation was ongoing during site visit.

Report Photo #1 "Topsoil as Berm" at GPS Coordinates:

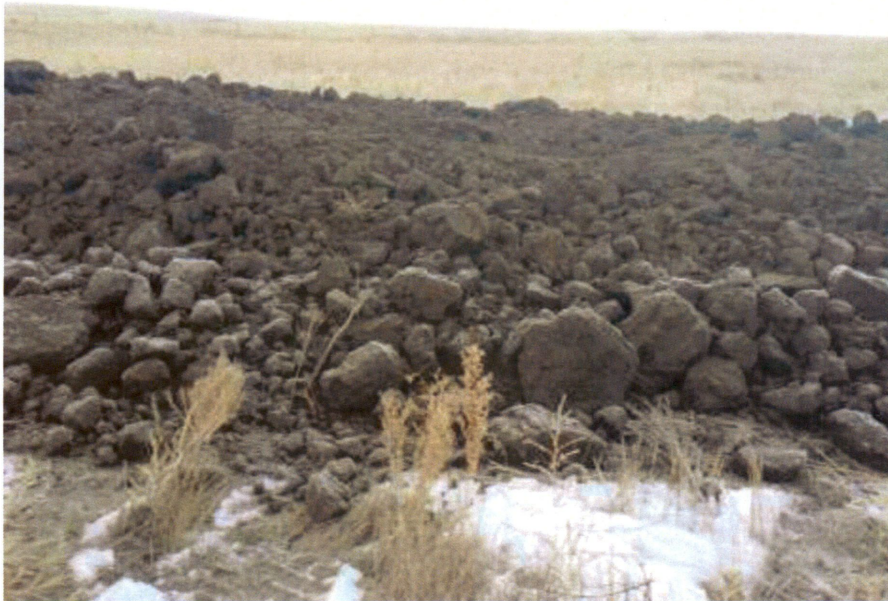
Report Photo #2 "Topsoil Separated" at GPS Coordinates:

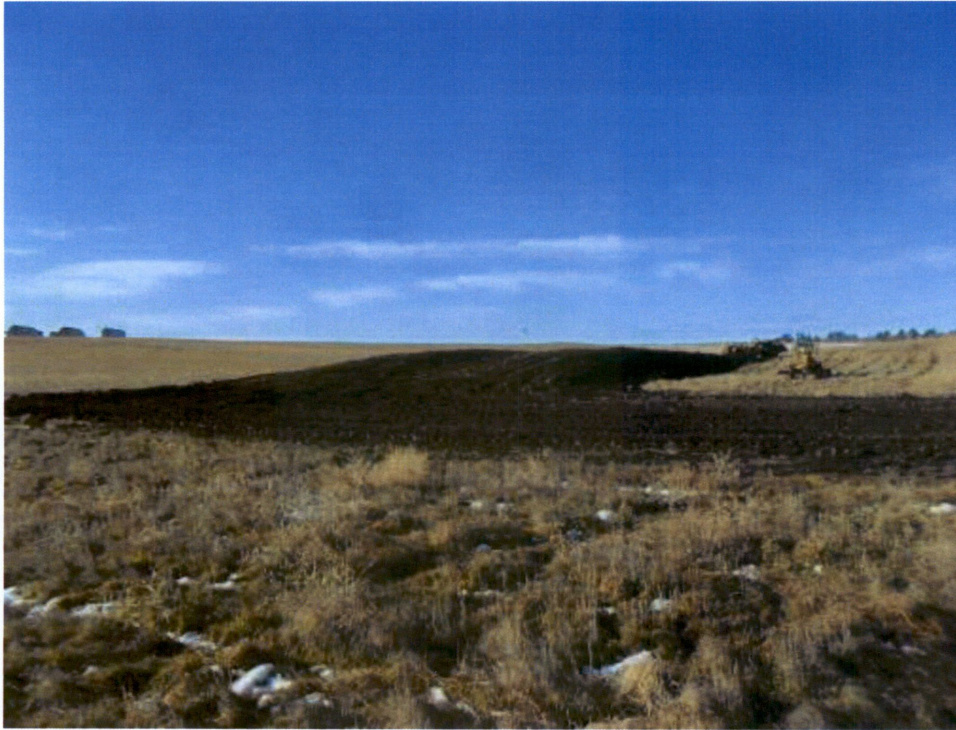
Topsoil was being moved for storage at south area of the site. Depth of topsoil stripped averaged about 1 foot. Topsoil from subsoil segregation appears adequate.

Report Photo #1 "Topsoil Piling on South Side" at GPS Coordinates:

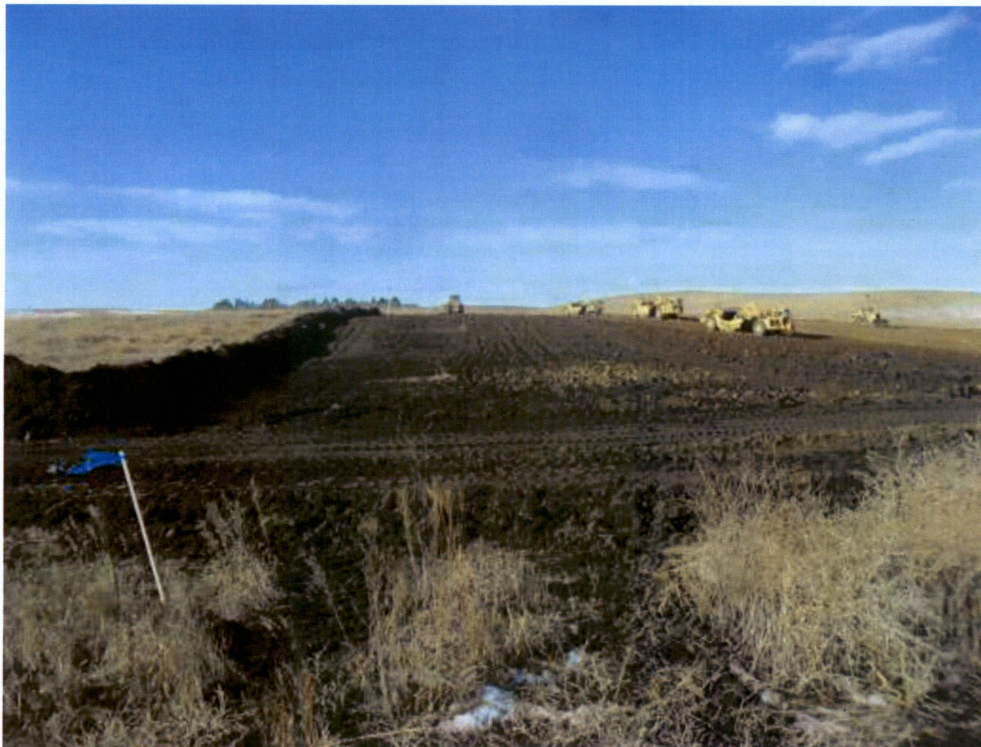
Report Photo #2 "Stripped Ground" at GPS Coordinates:

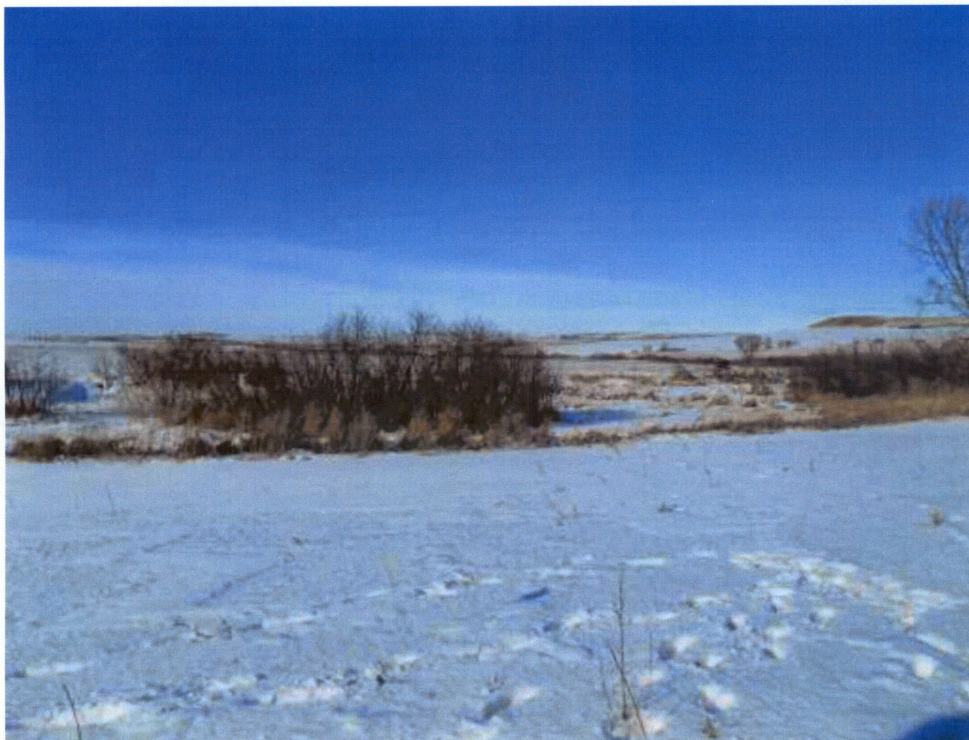
Trees remain in the northwest corner of the site, consistent with historical aerial photo dated August 2013. No evidence of tree or shrub removal noted at this time. Site personnel stated trees and shrubs may need to be removed to build an access road.

Report Photo #1 "Potential Tree and Shrub removal area" at GPS Coordinates: 47.80252°N 102.9272°W

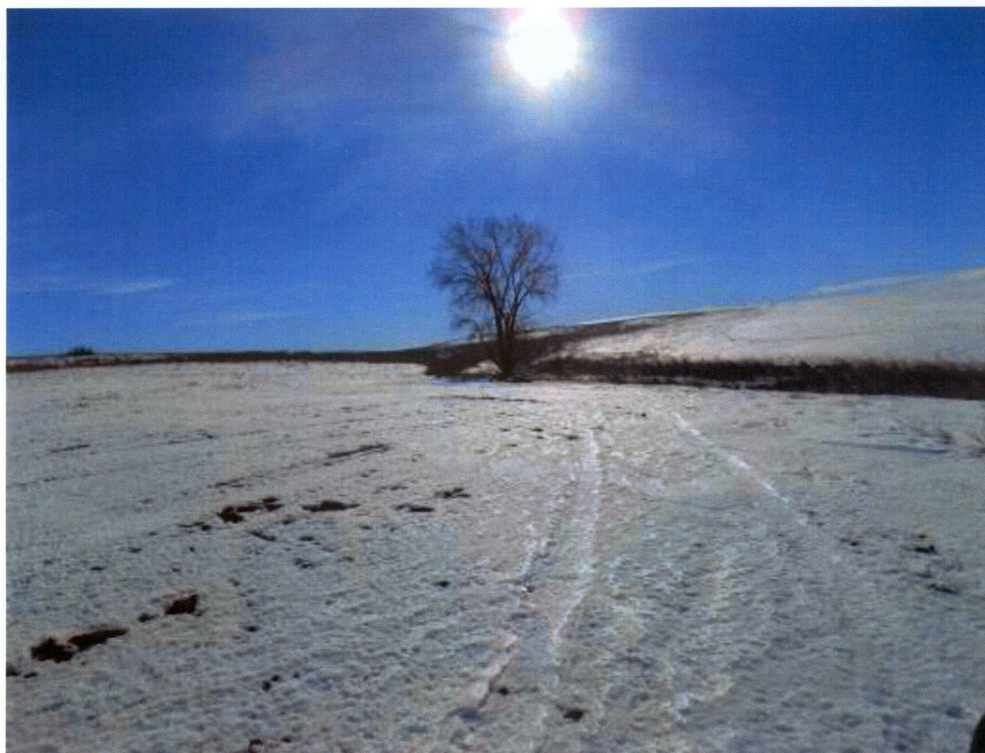
Report Photo #2 "Drainage path running through property" at GPS Coordinates: 47.8012°N 102.9258°W

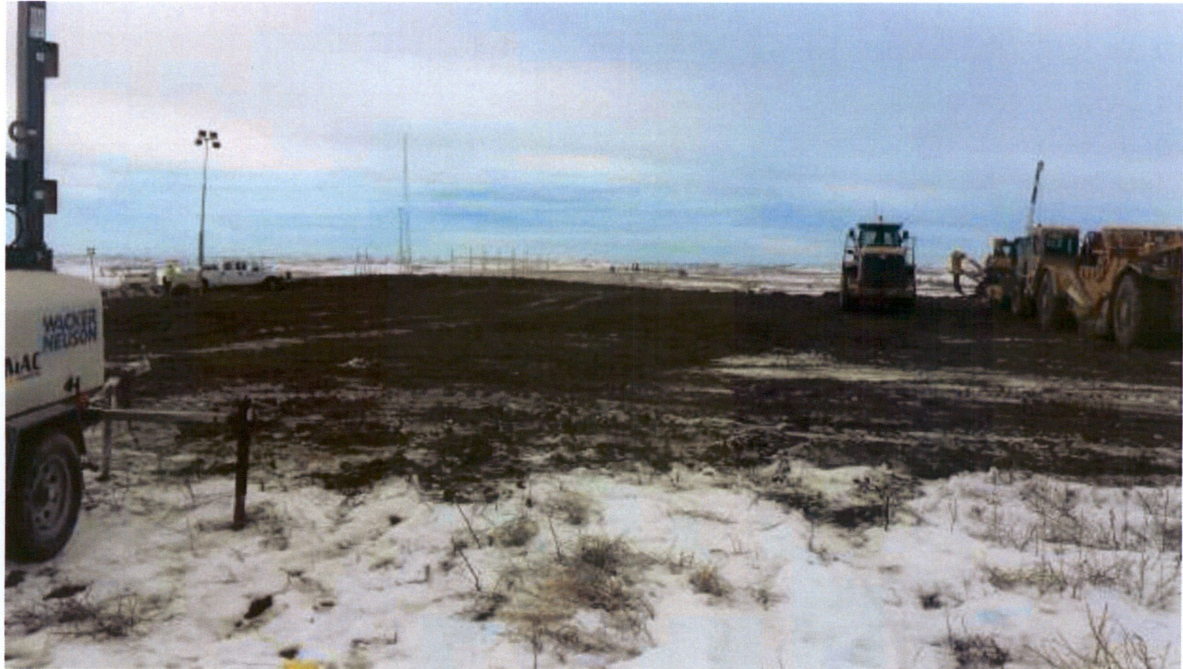
Report Photo #1 "Stripping Vegetation" at GPS Coordinates:

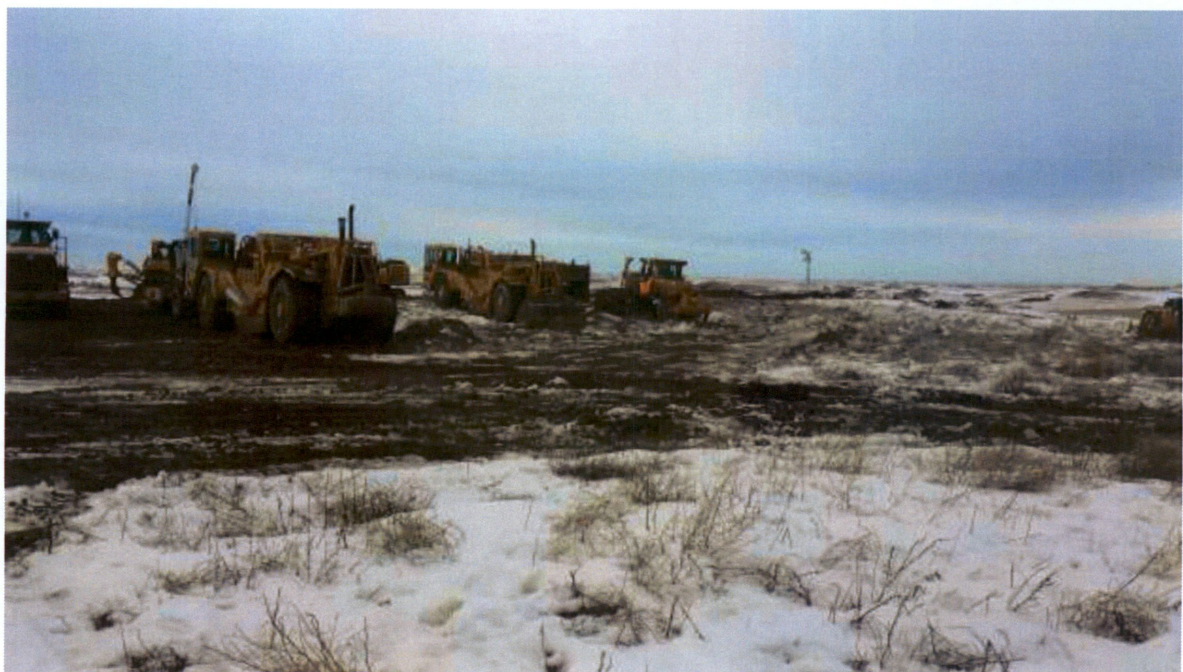
Report Photo #2 "Equipment Staging Area" at GPS Coordinates:

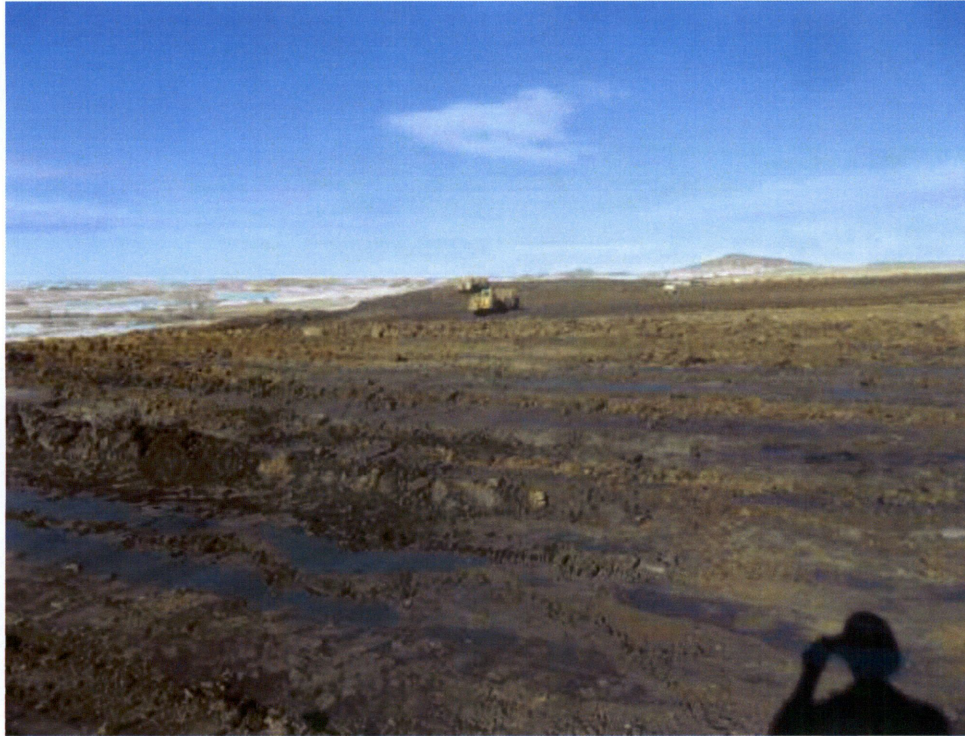
Topsoil segregation from subsoil appeared to be inadequate in a few areas. Subsoil mixing with topsoil seemed unavoidable due to warm weather thawing and softening the bare ground.

Report Photo #1 "Stripped Grounds" at GPS Coordinates:

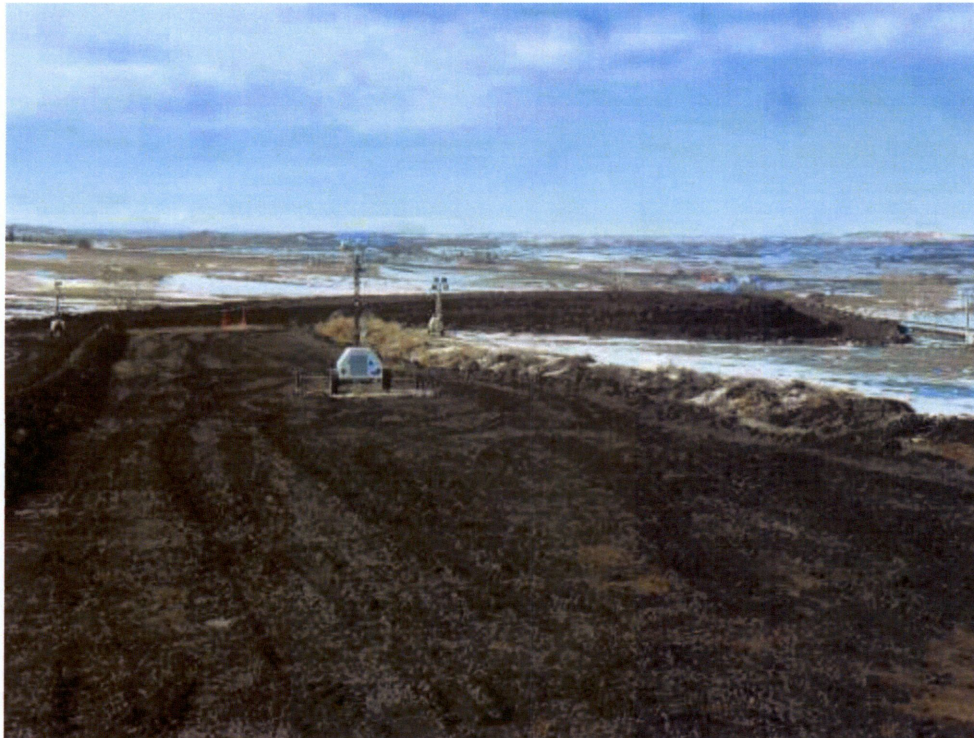
Report Photo #2 "Topsoil Pile" at GPS Coordinates:
